The Hidden Bridges of the Mountain River and its Tributaries

by Francis Coady

1st November 2012

APPENDIX 1 - BRIDGE RECORDING SHEETS

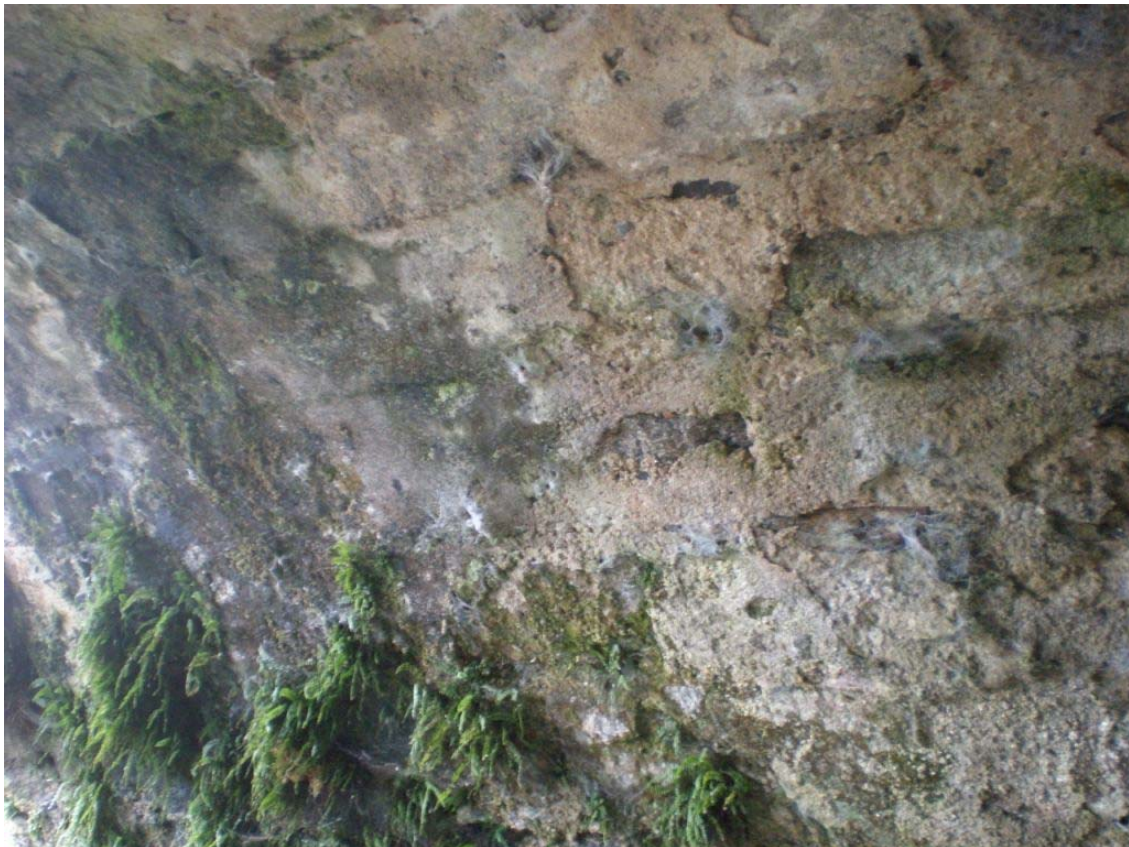
Plate 1 – Western elevation of Rathanna Bridge

Condition: Moderate to good. Water ingress has led to binder migration in the mortar and damp patches on either side of the barrel show signs of black staining. Pointing is needed in places where the lime mortar has perished.

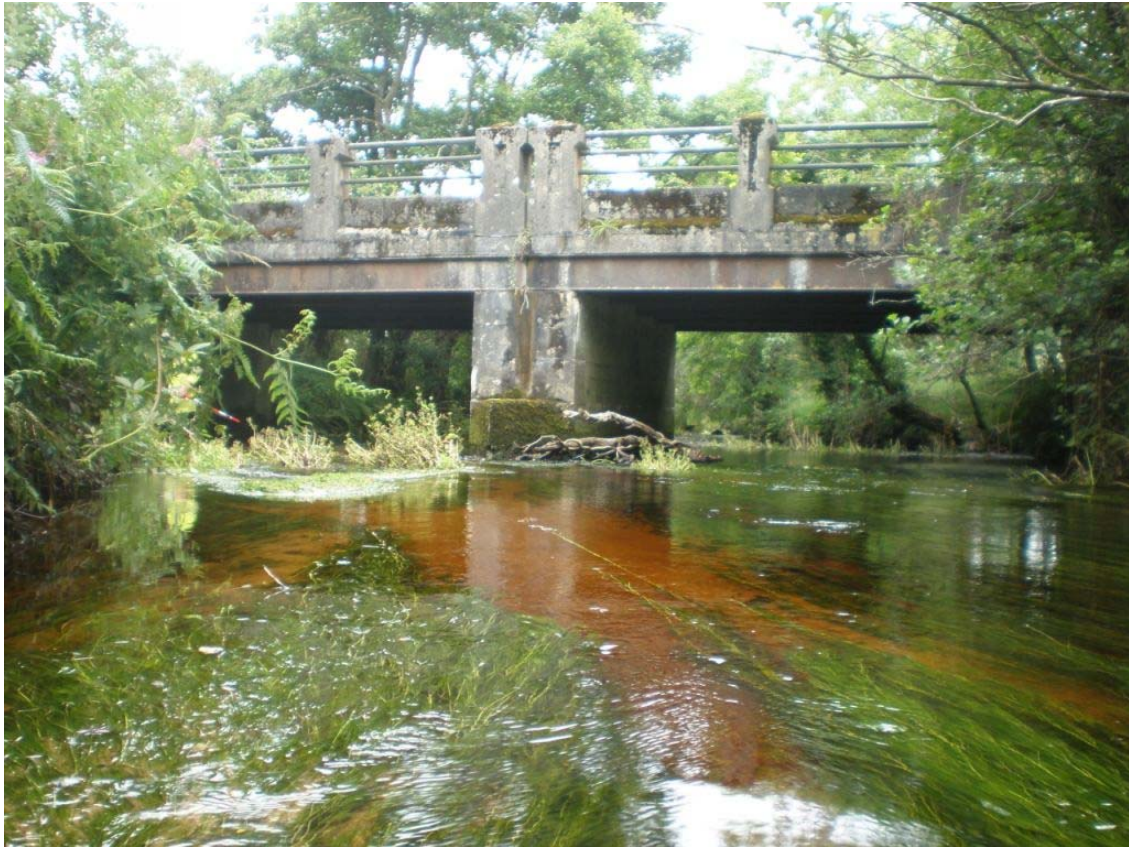
Plate 6 – Southern elevation of Moyvalley Bridge

Condition: The bridge is in relatively good condition. Scouring has taken place on the central pier under the bridge. The steel beams are heavily oxidised, and the mesh above these beams has also oxidised leading to the cover of concrete spalling in places. As a result of water penetrating from the grass verges on the road surface calcite has leached from the concrete.

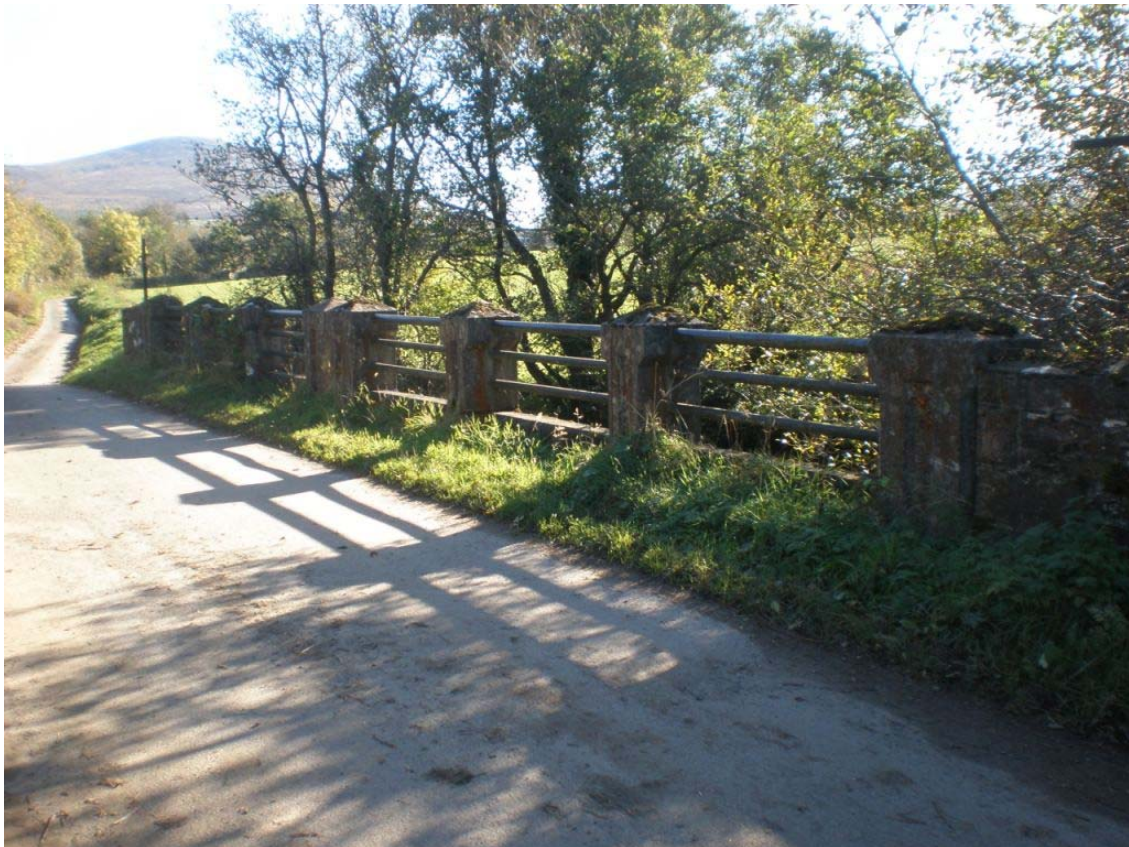
Plate 7 – Concrete post and tubular steel parapet

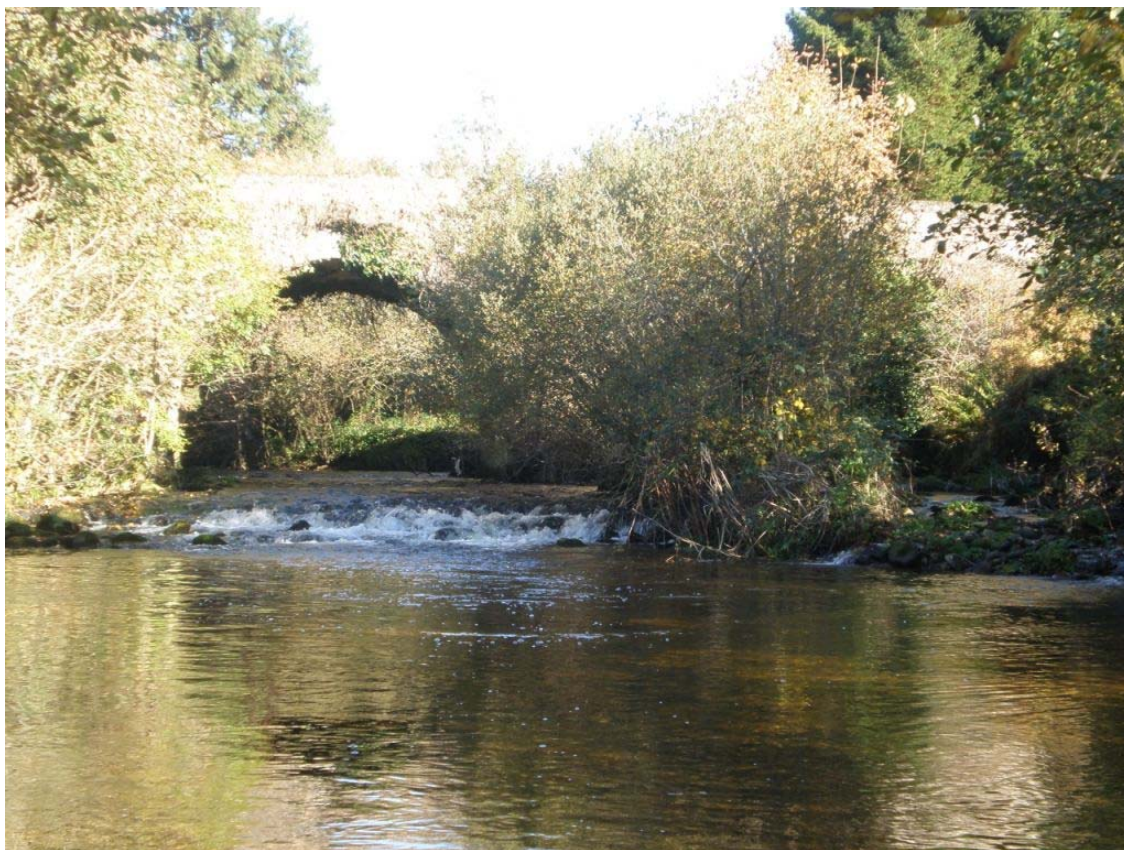
Plate 7 – South-western elevation of Rosdellig Bridge, overgrowth masks eastern span

Condition: Lime mortar has perished to the rear of the voussoirs. Within both barrels there are cracks that extend from the abutments into the barrel. Water penetration from road level has lead to moisture migration. Also, the lime mortar has perished on the eastern side of the abutment wall due to damp, shaded conditions, with this section of the wall having a large bow present. The side arch also has a considerable crack to the rear of the voussoirs.

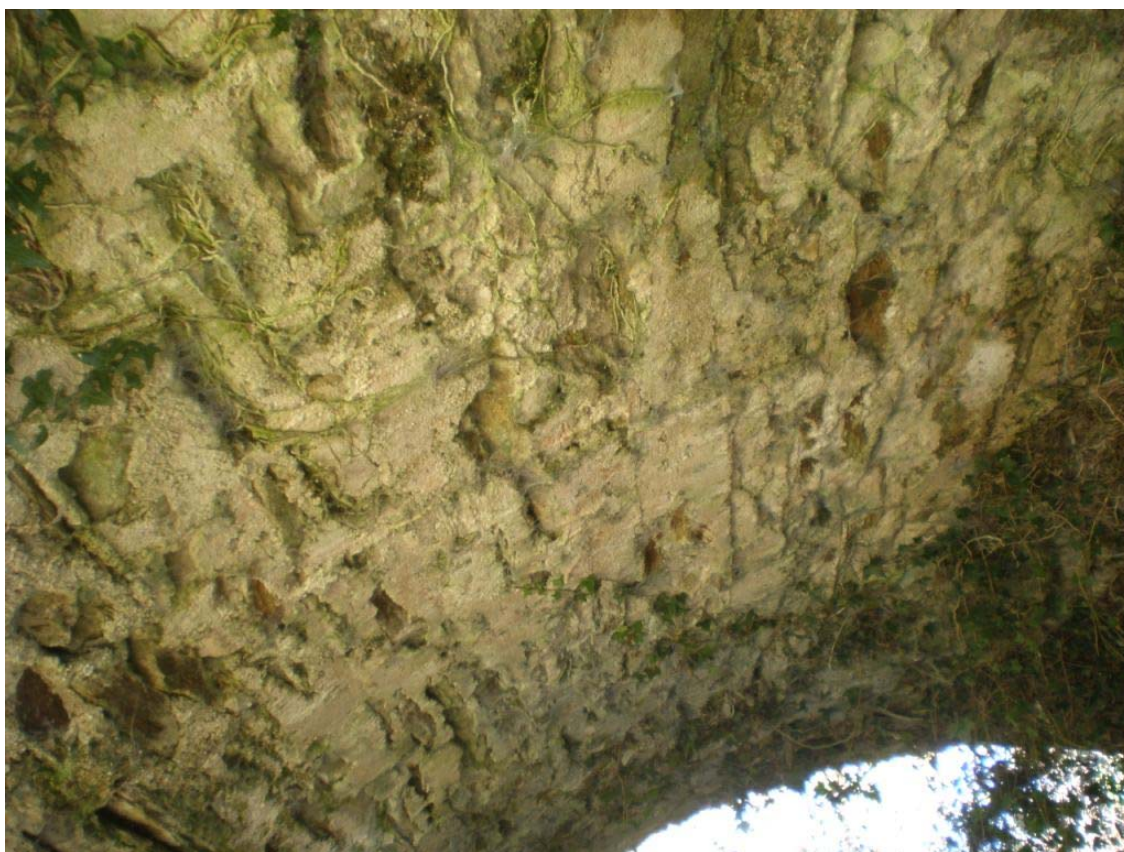
Plate 9 – Outline of centring remains on the barrel of Rosdellig Bridge

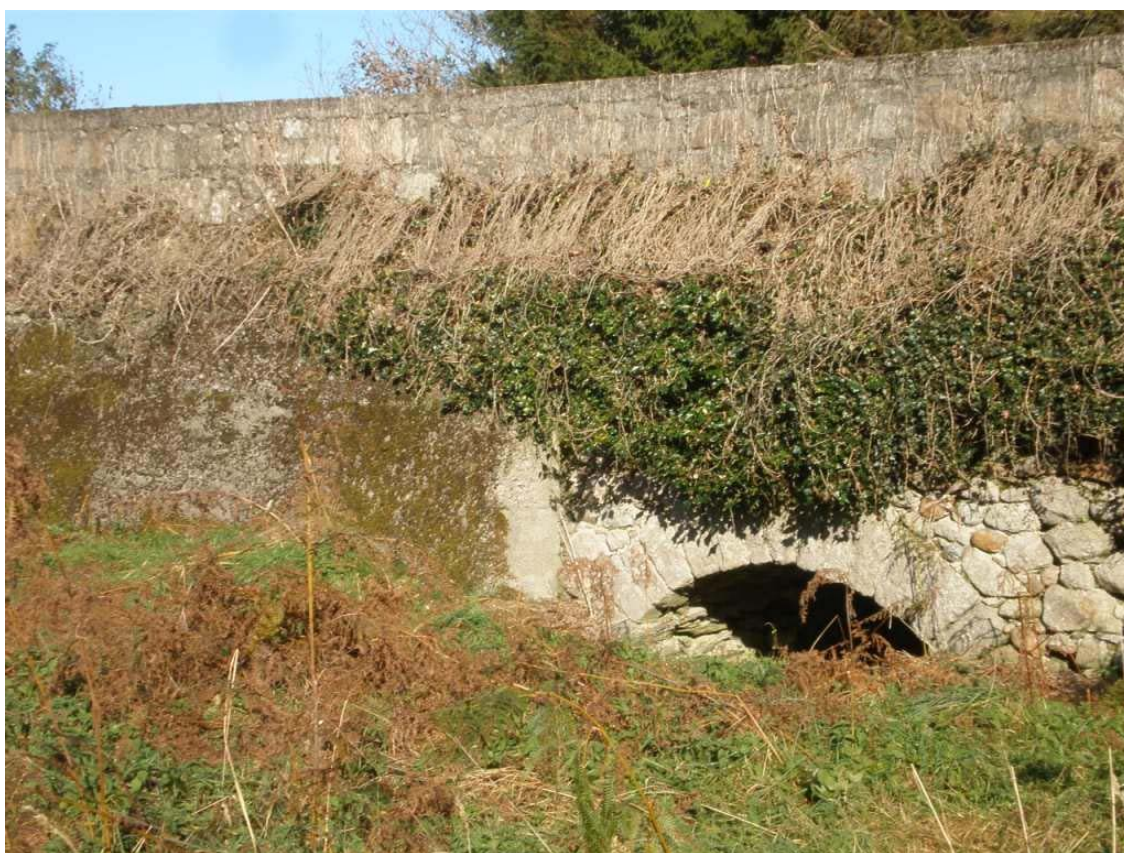
Plate 10 - Arch and later concrete abutment on south-eastern elevation

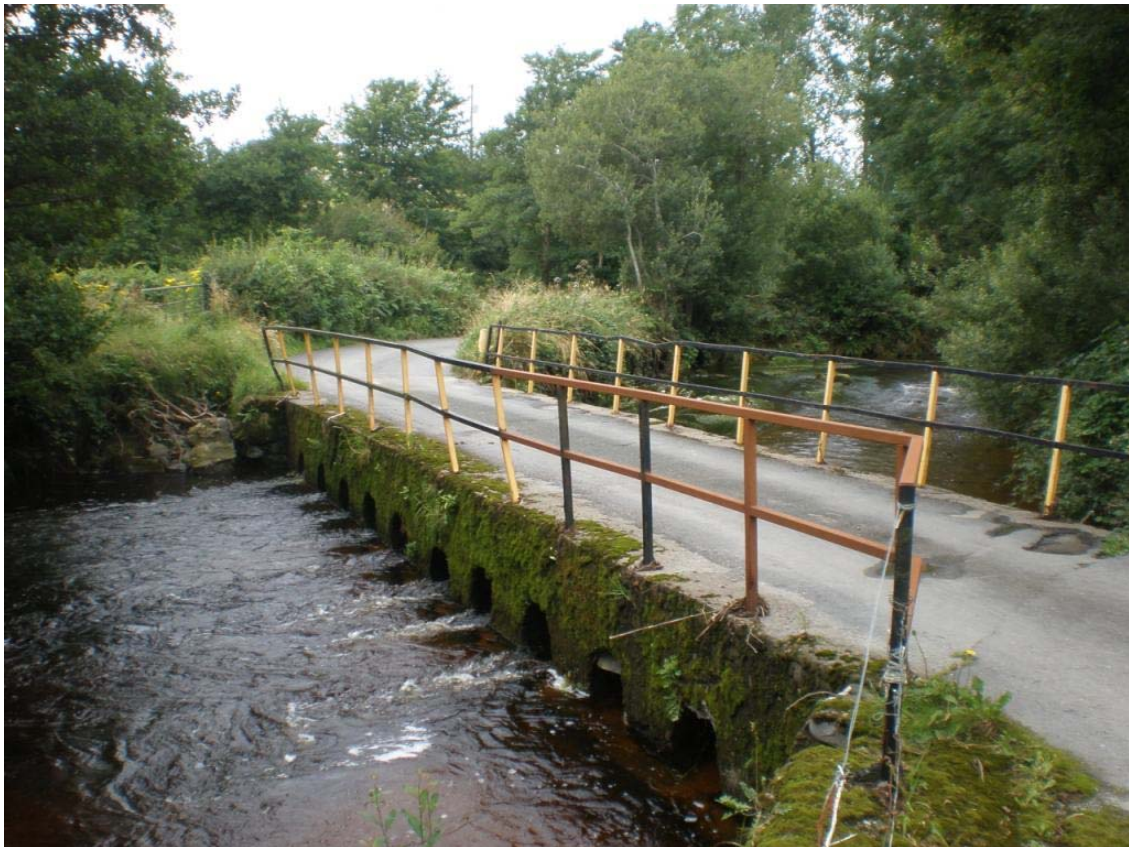
Condition: The railing is in a poor condition, rusted and bent in places. The concrete is in moderate condition.

Plate 12 – Brooke Lodge with steel parapet

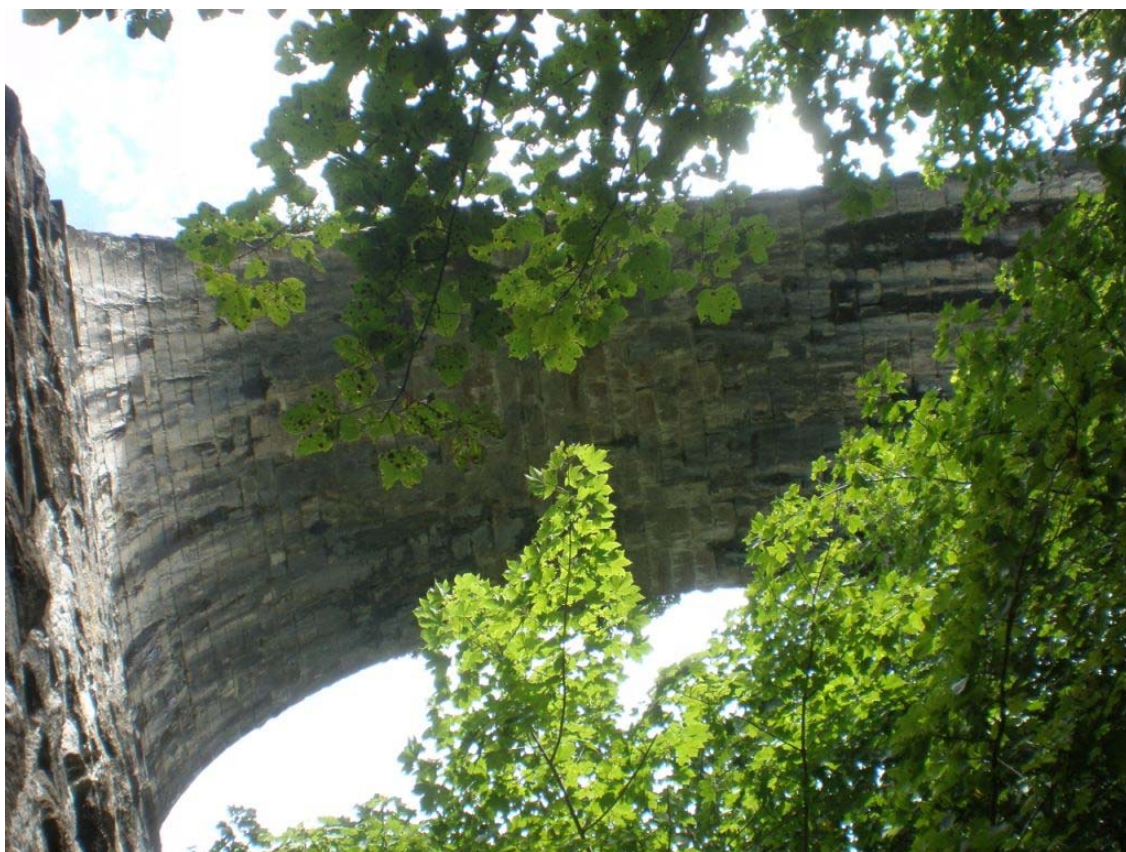
Some of the stones in the piers are up to 2m in length. A considerable amount of calcite has leached from water ingress above leading to black and white staining. The plug and feather marks are visible on some of these stones.

Plate 13 – Barrel of Viaduct, view from the Mountain River

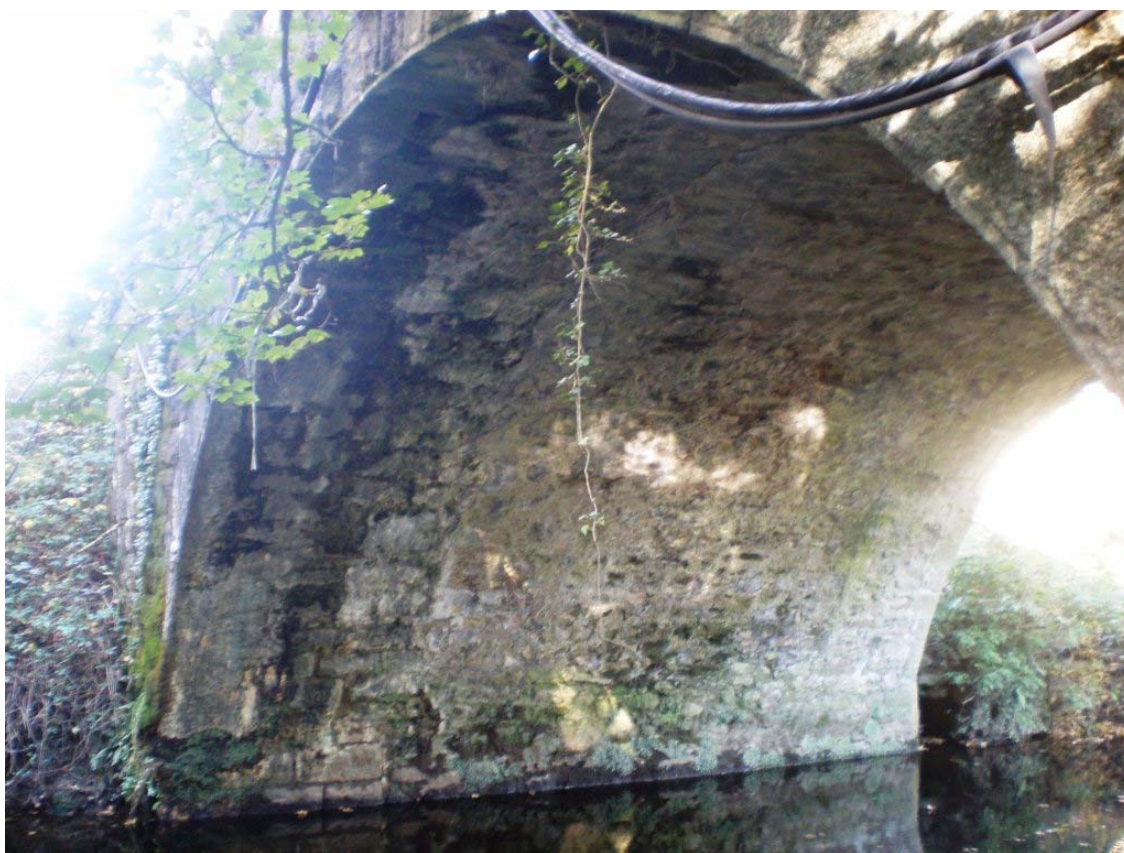
Condition: A considerable amount of leaching of calcite from the lime mortar used in the construction of the bridge may be seen on the barrel. This is due to water penetration from the road surface above, it has also led to black staining. Mortar has perished behind the voussoirs on the west side of the bridge. The joint that extends through the barrel from bank to bank has been widened in recent years due to water penetration from above.

Plate 17 – Barrel of Ballycoppigan Bridge, note difference between east and west side

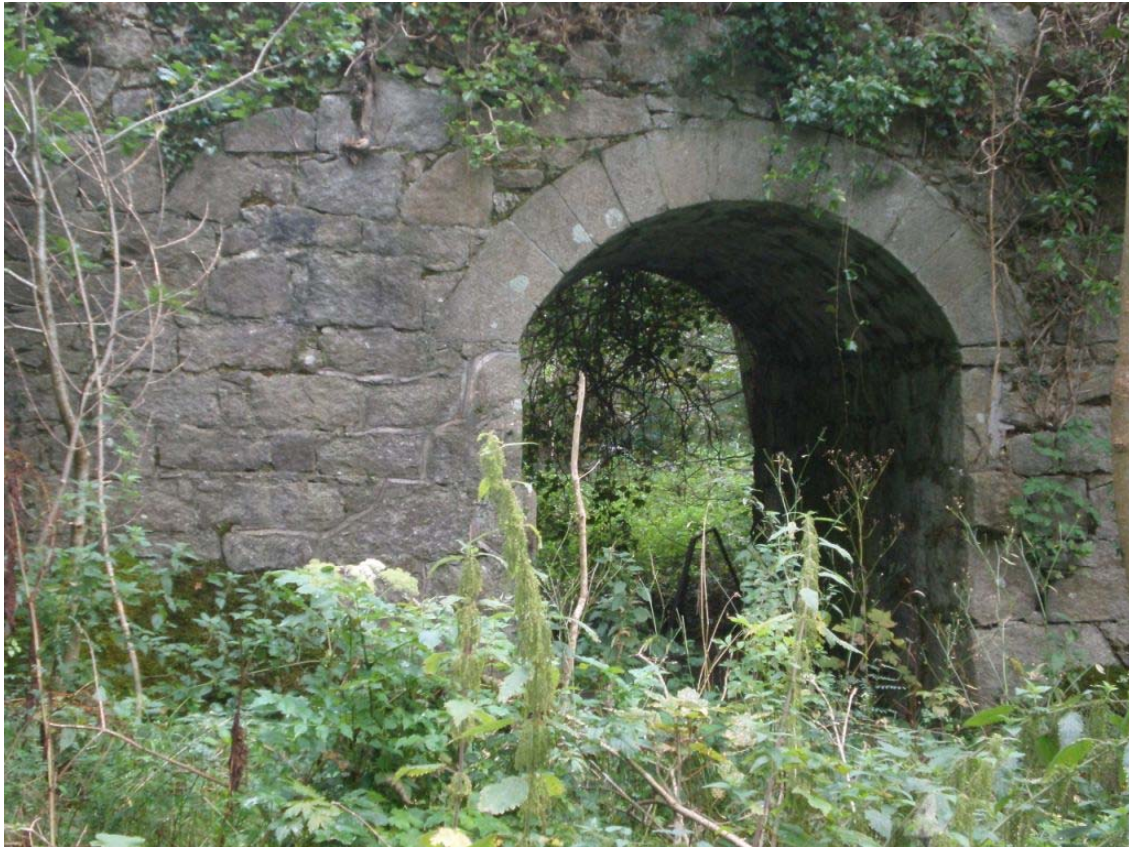
The arch itself may have been used to accommodate excess water in times of flood or may have been used for a pedestrian route. It now accommodates a drain and has a concrete floor as its base. There are many cracks within the barrel of the arch and again it is due to water penetration from above. The lime mortar has perished in many areas and a considerable amount of calcite leaching has occurred. Later cement remedial works have been undertaken here but have been unsuccessful as they have not adhered to the stone.

Plate 20 – Arch in abutment wall of Saw Mills Bridge, western elevation

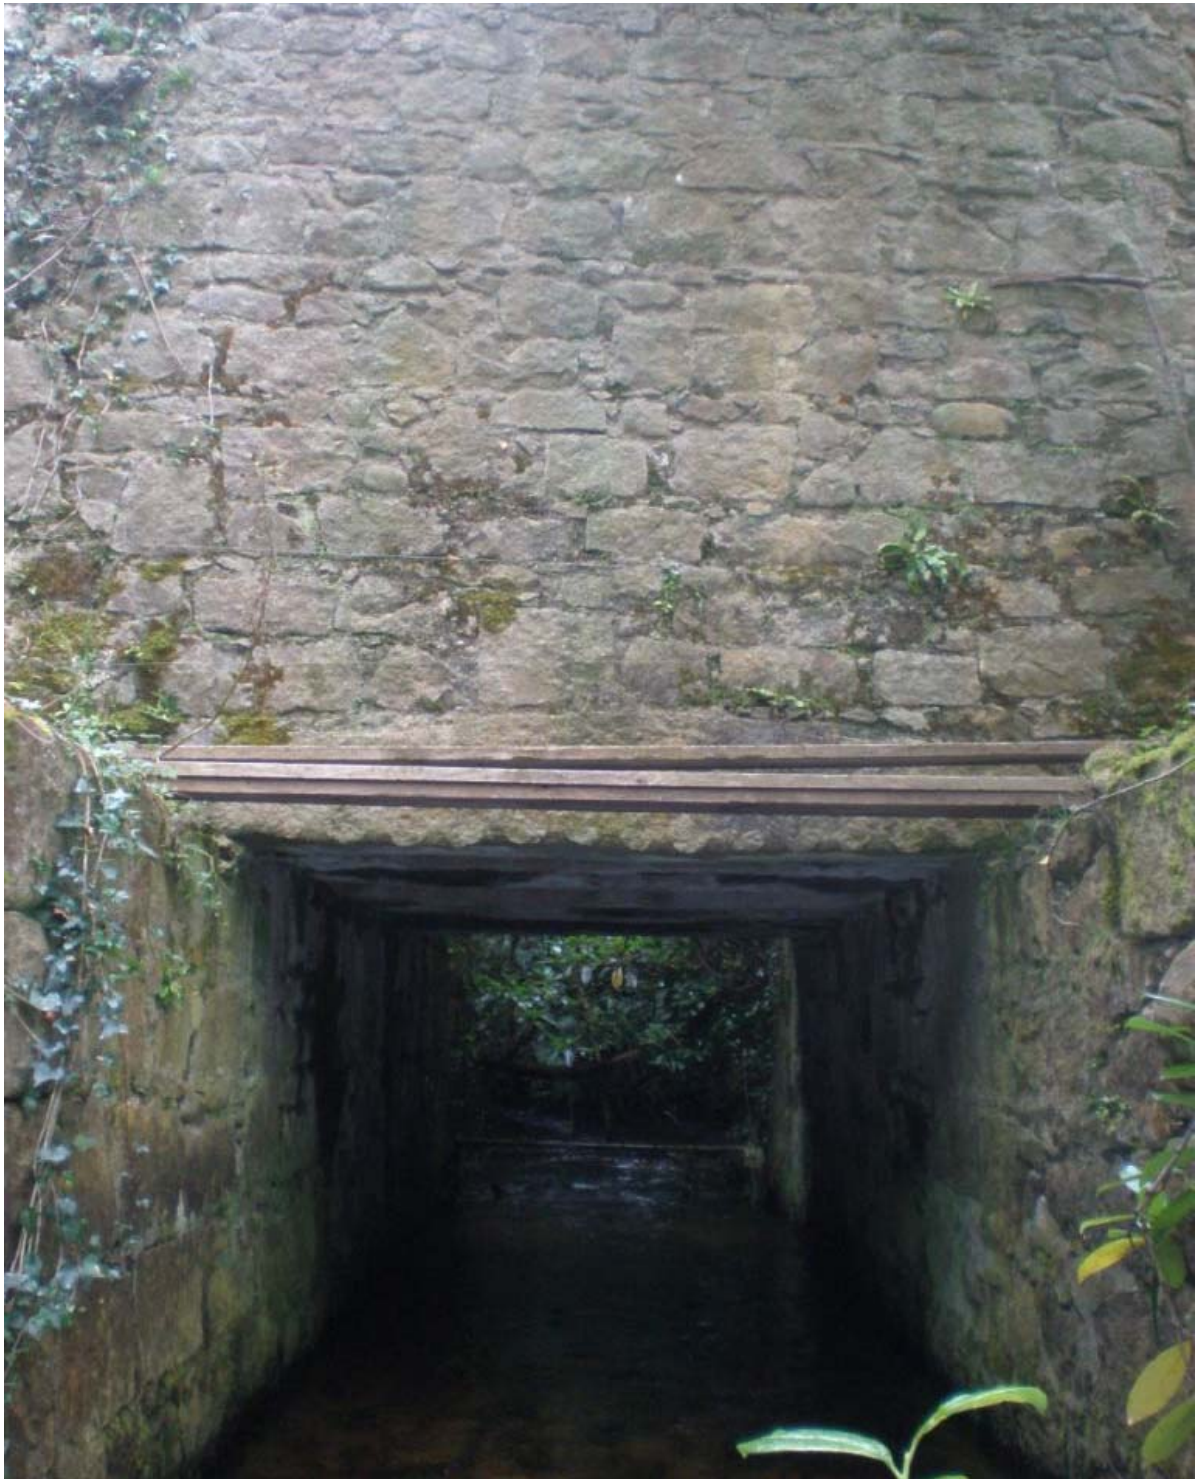
Plate 21 – Western elevation of Mill Race Bridge, note plug and feather marks on lintel

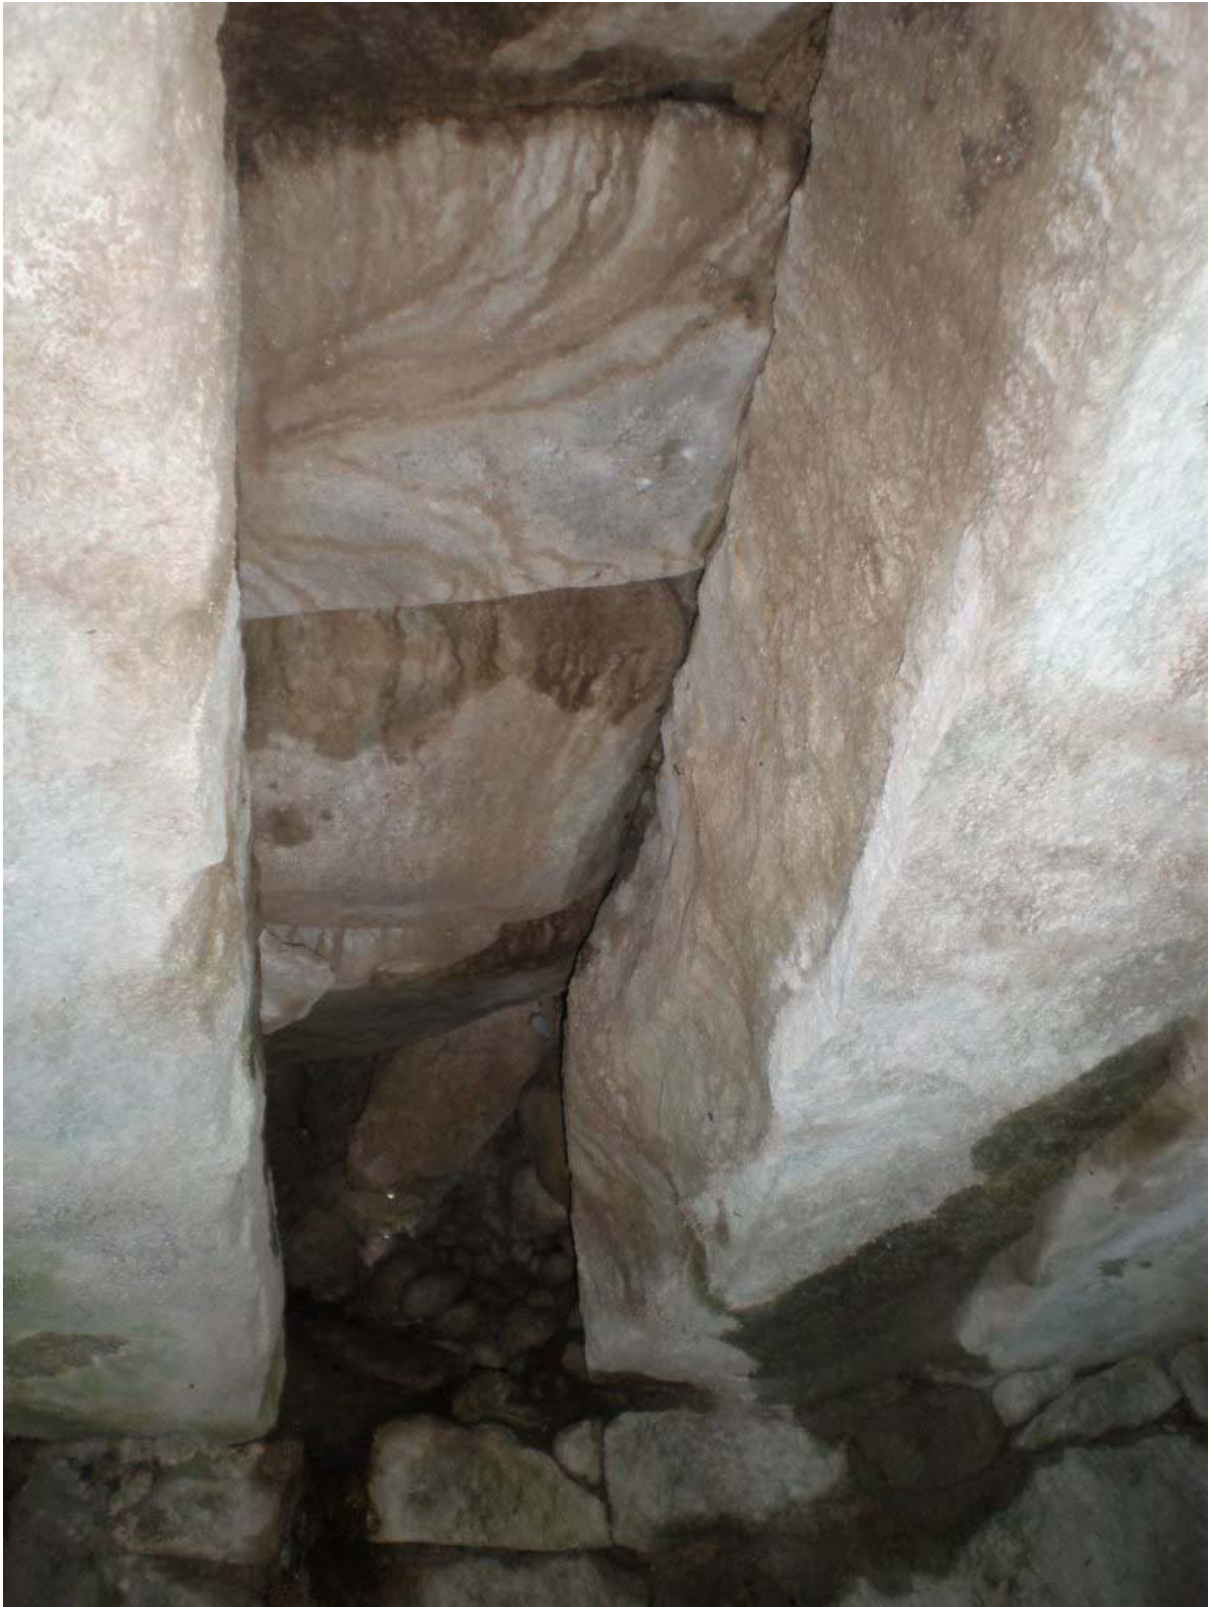
Condition: There is slight bulge in the eastern abutment wall due to water and freeze thaw action. Water ingress from above has led to binder migration and failure of the mortar in places; these have resulted in sand cement repointing remedial works. On inspection under the bridge there is a lintel missing.

Plate 22 – Missing lintel in soffit, note the lattice style construction

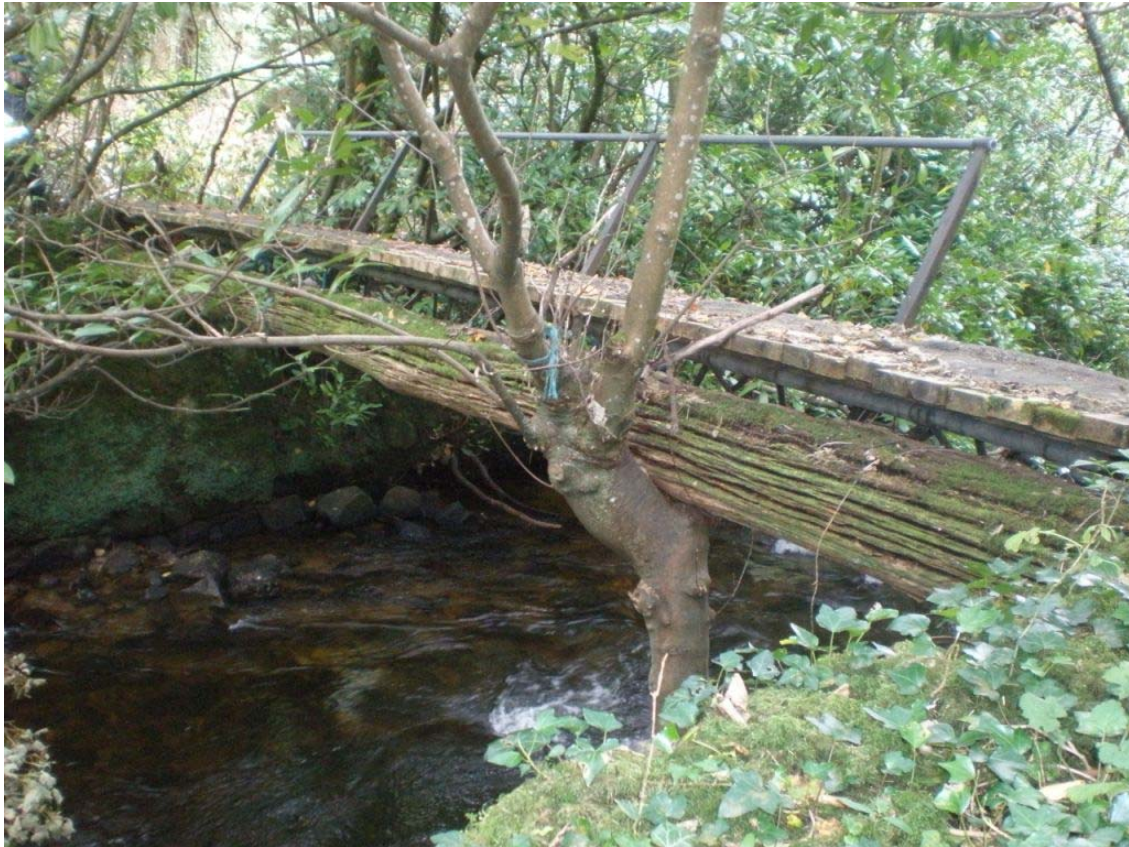
Condition: Poor condition, the timber is badly decayed leading to the bridge being unstable.

Plate 23 – Tree acting as support for Foot Bridge

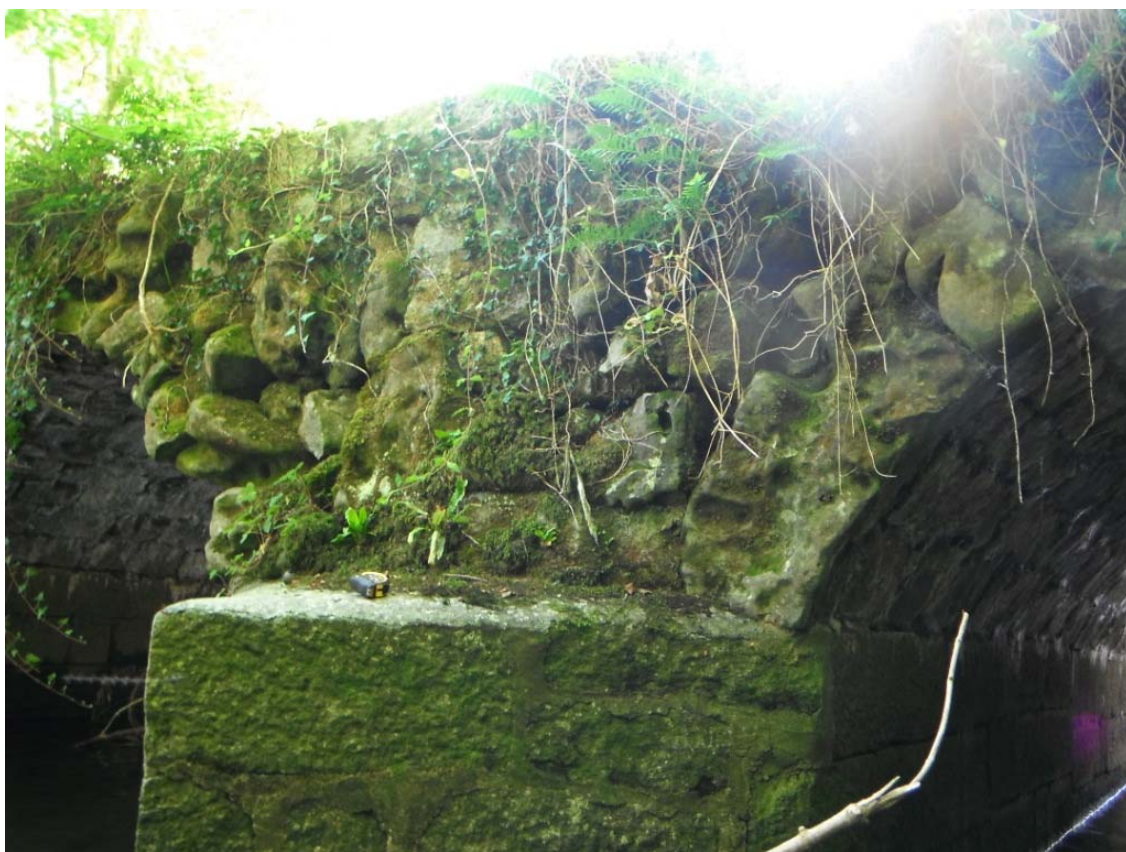
Condition: The bridge is in relatively good condition except for one of the cutwaters, which has started to break up. There is a considerable amount of calcite leaching from the core of the bridge, due to the surface above being unsealed. Cement remedial repointing has been undertaken in areas like the cutwater.

Plate 31 – Random rubble spandrel, with triangular cutwater

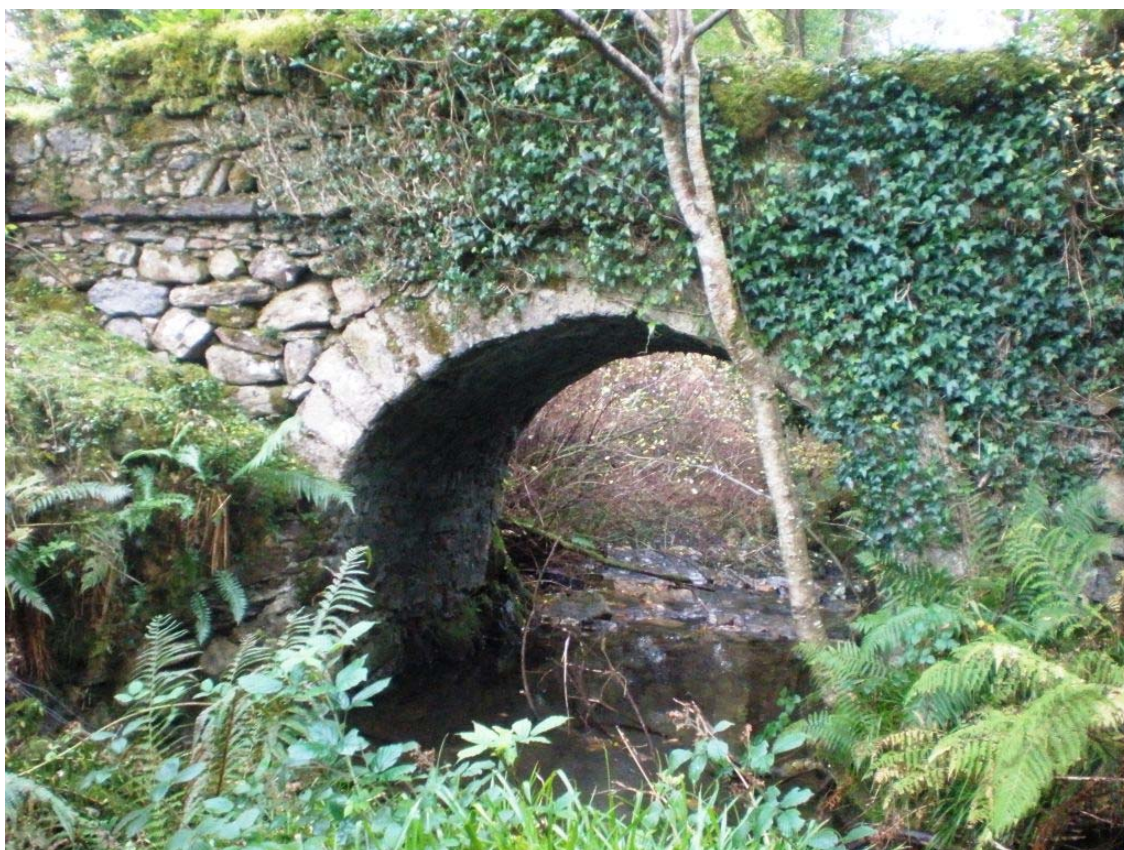
Condition: While the parapet of the bridge is in extremely poor condition, the barrel underneath is in relatively good condition. The southern parapet of the bridge is almost completely gone, having been pushed or knocked into the river down through the years. More of the northern parapet remains but it is leaning perilously over to one side and is real danger of collapse.

Plate 33 – Eastern elevation of the first bridge on the Killedmond River

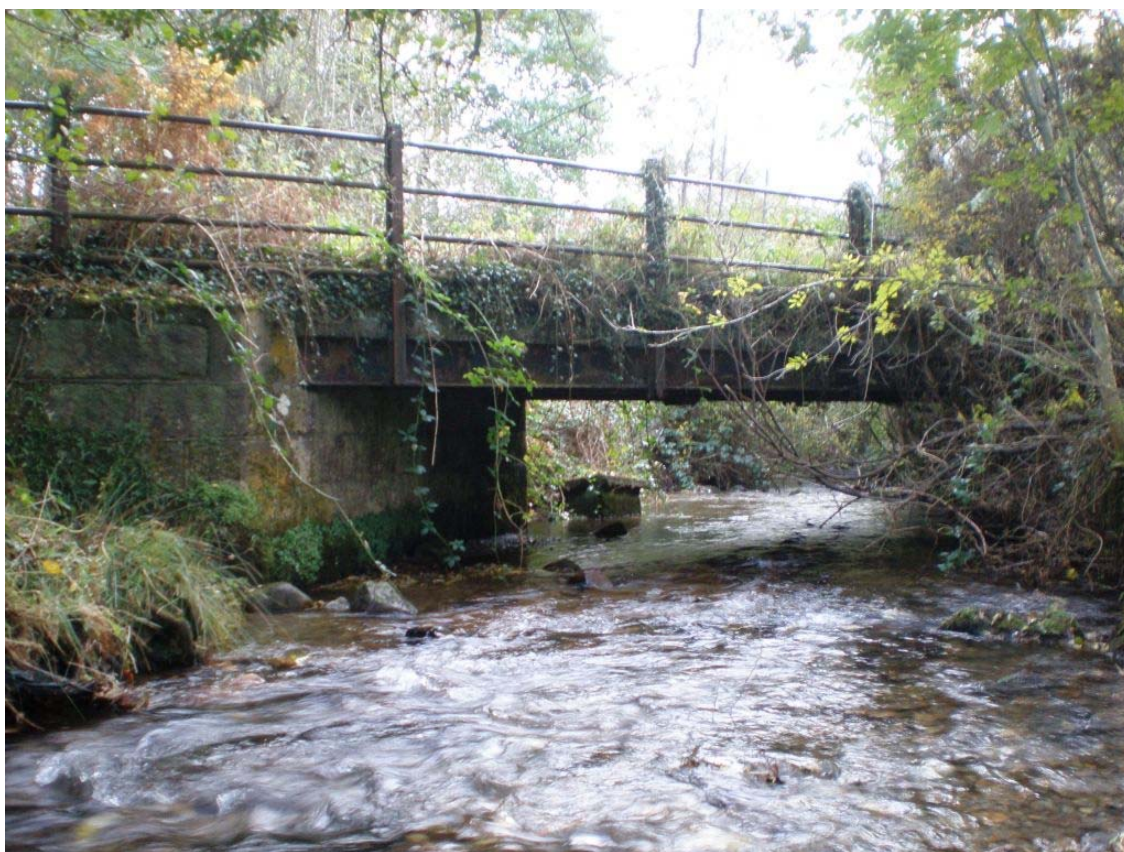
Condition: The bridge is in relatively good condition. The abutments and paving under the bridge are in good condition, but the steel beams and the corrugated iron, are badly corroded. The concrete pillars and aluminium railing on the road surface are broken and corroded in places.

Plate 35 – North-western elevation of Raheen Lane Bridge

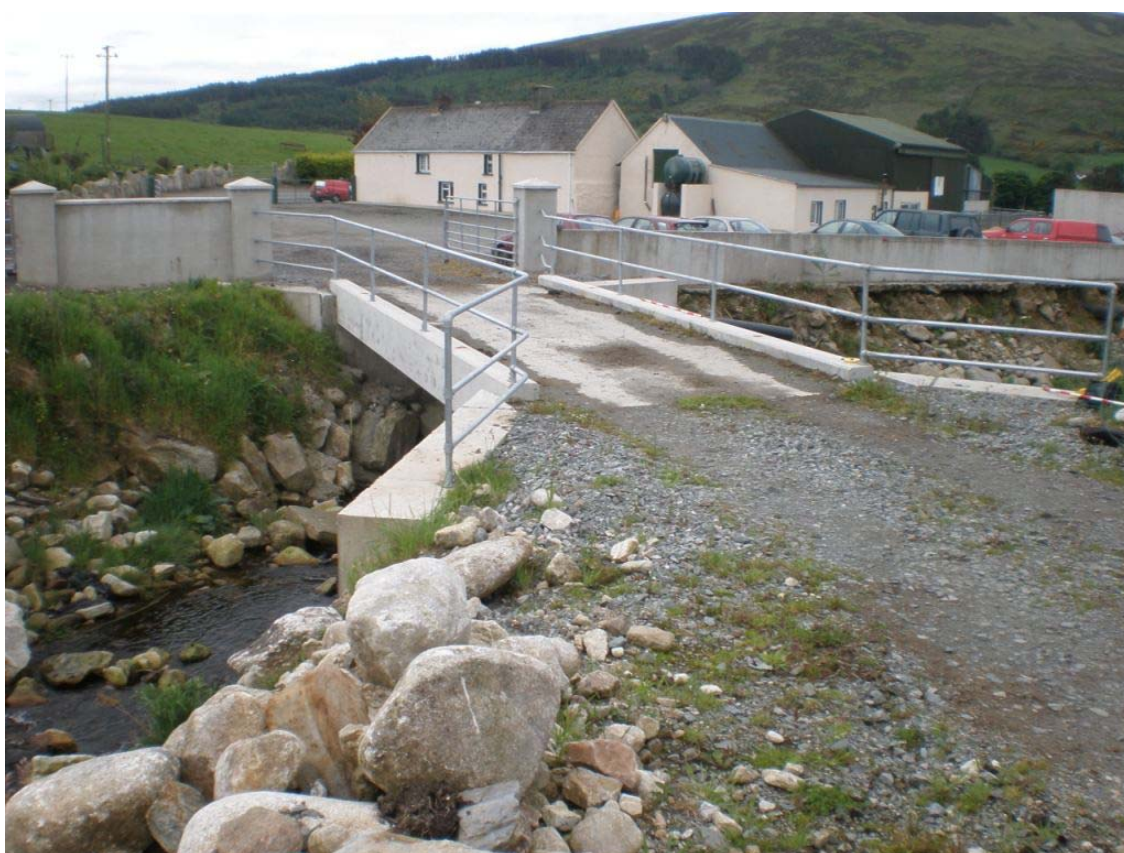
Plate 45 – Surface view of Wards Bridge, note deep scouring of the banks

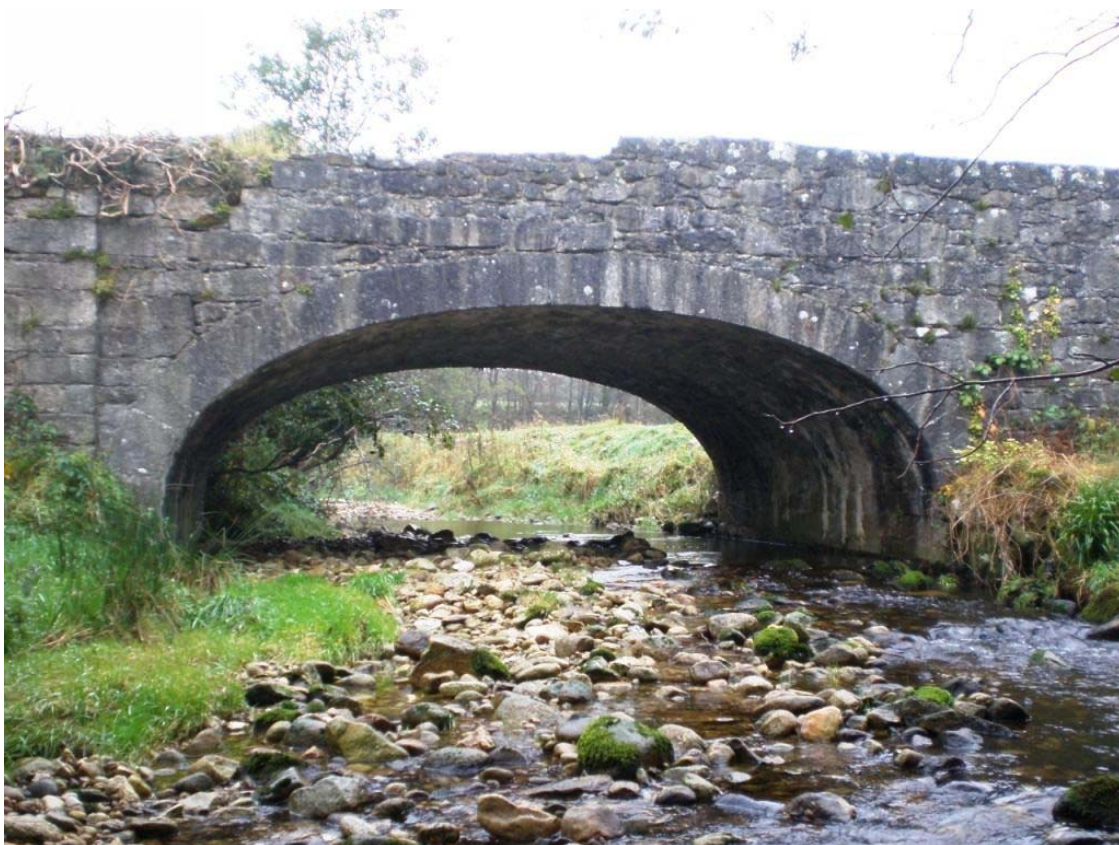
Plate 46 – South elevation of Scullogue Gap Bridge, with missing coping

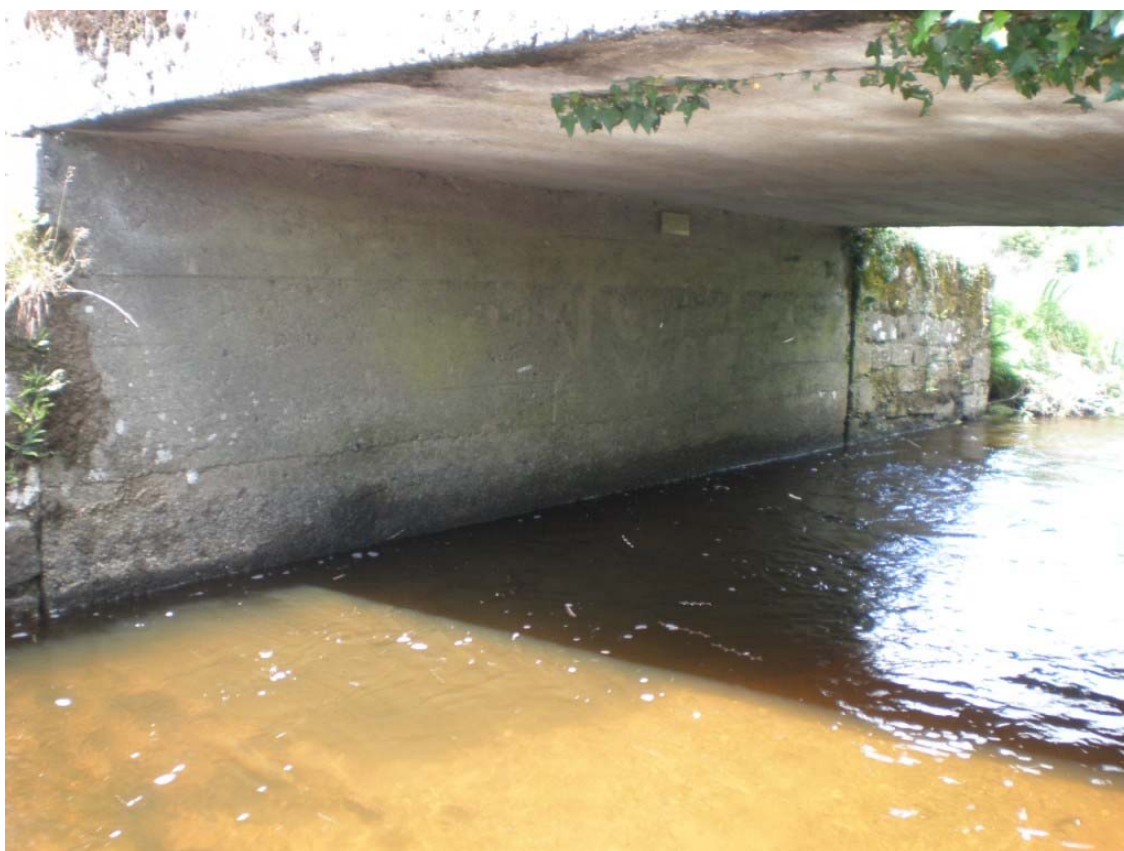
Plate 72 – Outline of timber formwork on abutment and soffit of Knockullard Bridge
