The Hidden Bridges of the Mountain River and its Tributaries

by Francis Coady

1st November 2012

APPENDIX 1 - BRIDGE RECORDING SHEETS

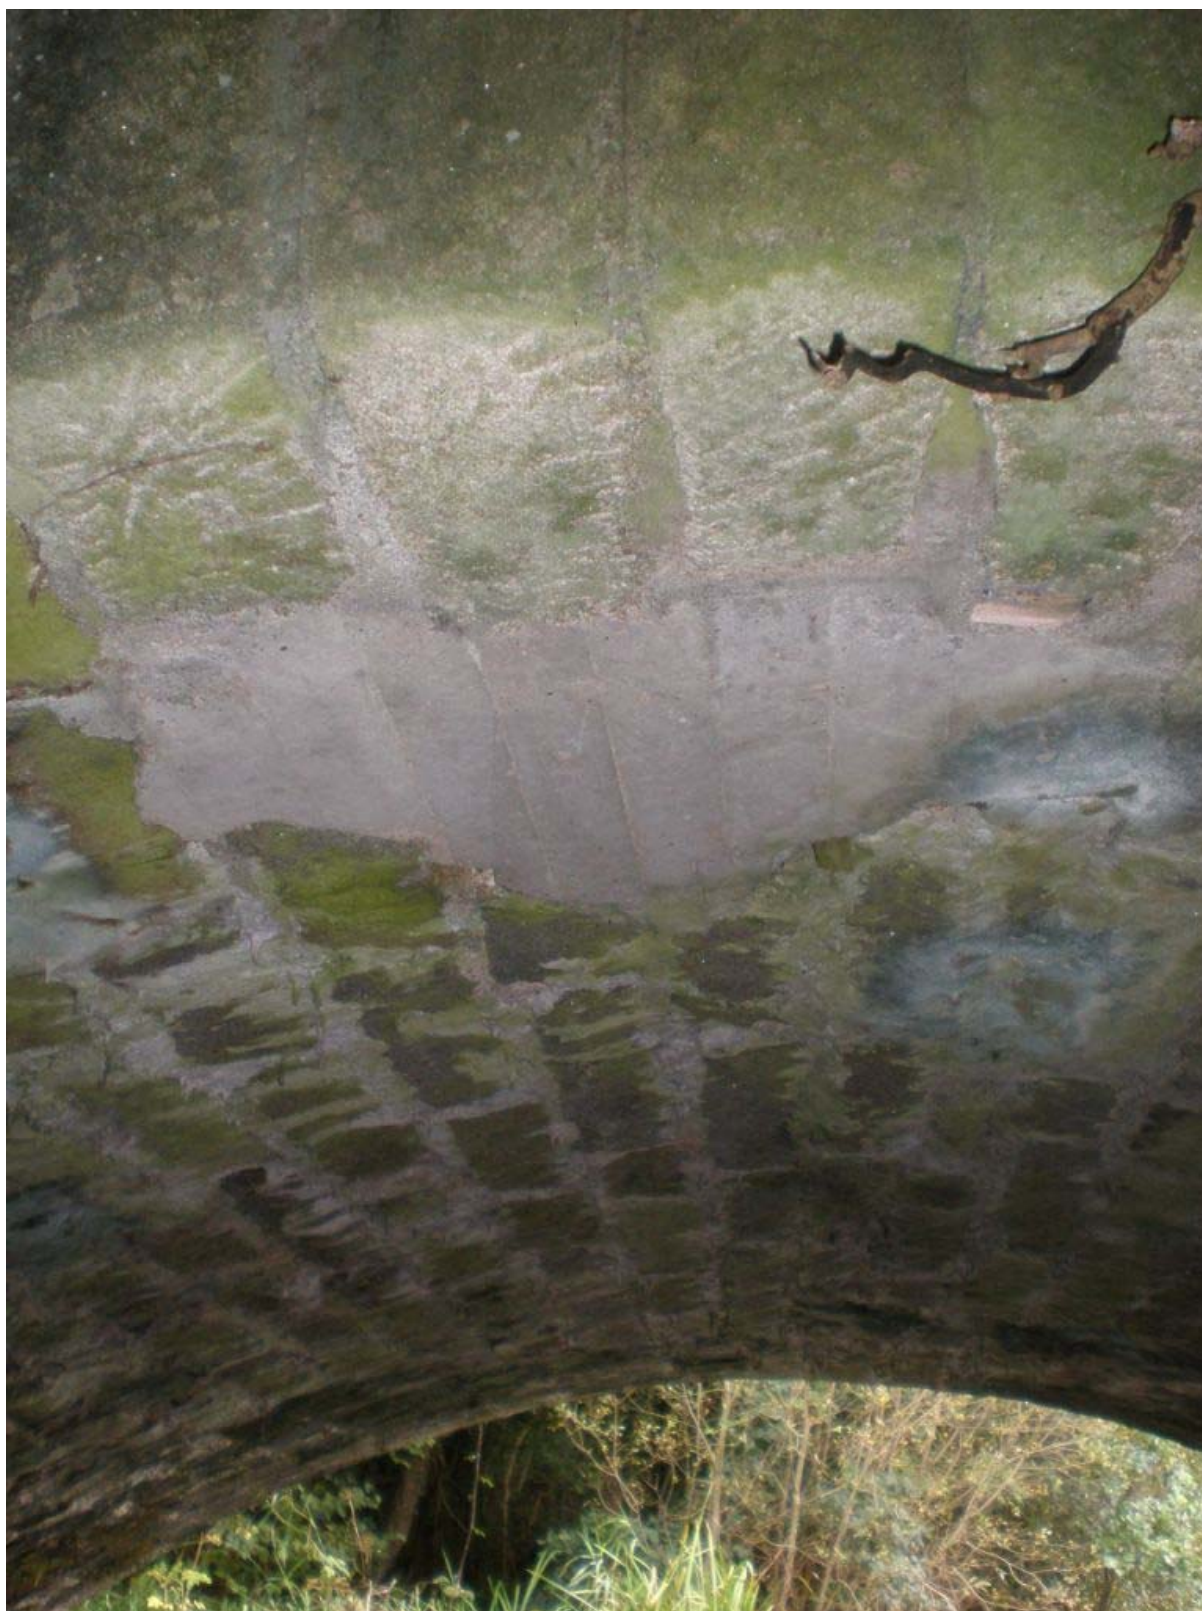
Plate 84 – Barrel of bridge, with later cement remedial work. Is this related to the attempted destruction of the bridge?
